# *Alpha Home & Commercial Building Inspections*

## Property Inspection Report

Industrial Building Inspection Report Sample  
Inspection prepared for: Commercial Building Inspection Client  
Real Estate Agent: Brian Phillips - Conway Commercial

Date of Inspection: 9/21/2016 Time: 1:00 PM  
Order ID: 4365

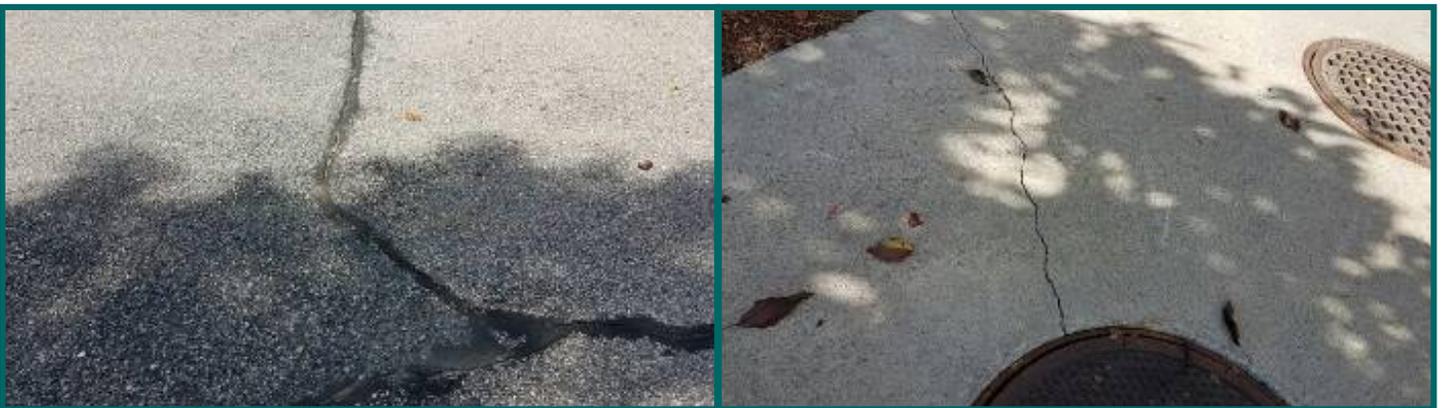
cracks at front sidewalk

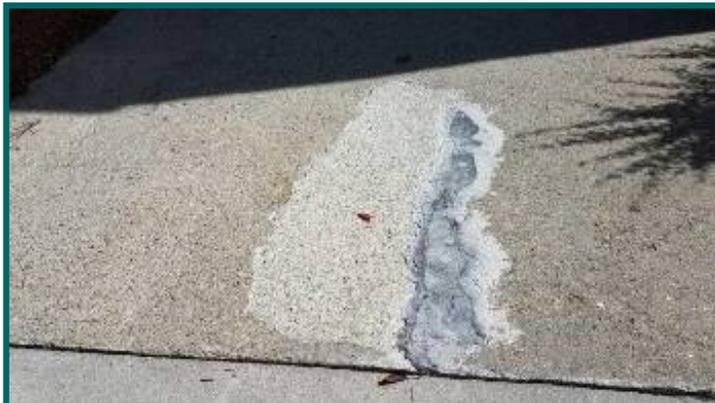
repairs at front sidewalk

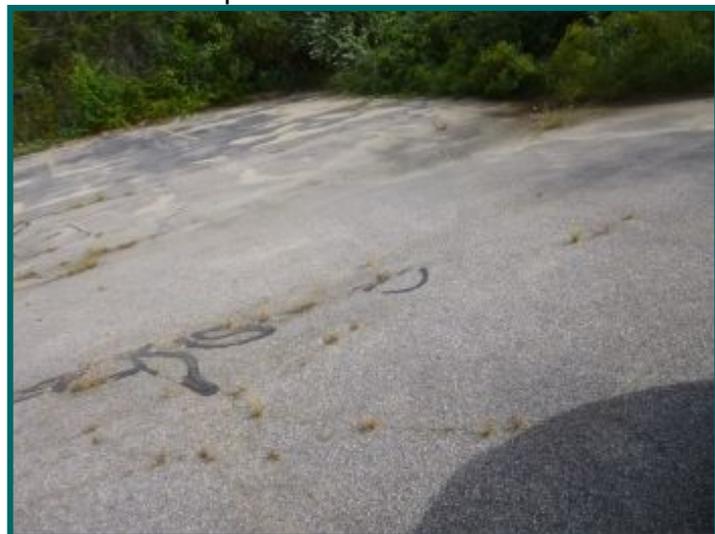
1.2. Drive way and parking lot have areas of improper grading, there are areas of depression that are conducive to water ponding and icing in winter. Recommend assessment by a qualified asphalt surfacing contractor.

Area at rear right lot , improper grading, water ponding reported.

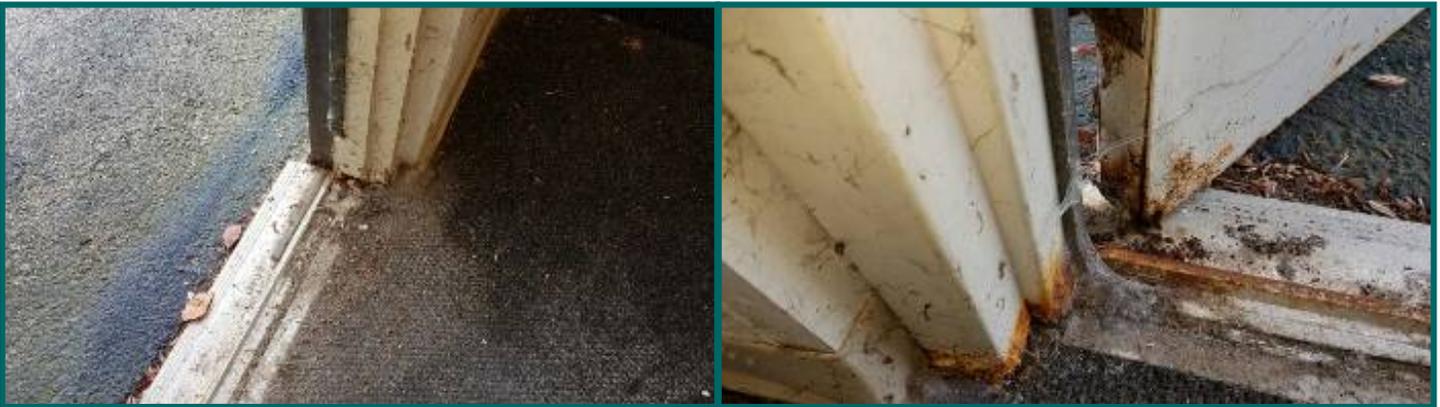
1.2. Corrosion, damage or deterioration on surface of door and or door frame at one or more area. Suggest repairs/replacement as needed.

Corrosion on door and frame left side wall

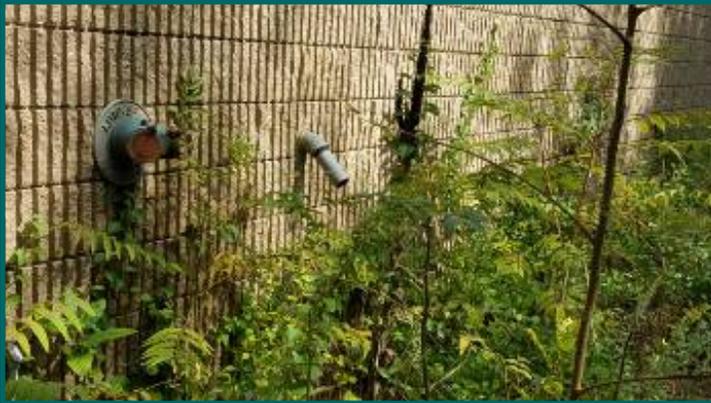
2.2. Wasp activity noted , recommend further investigation and treatment by a licensed pest control company.

bees swarming right side wall penetration

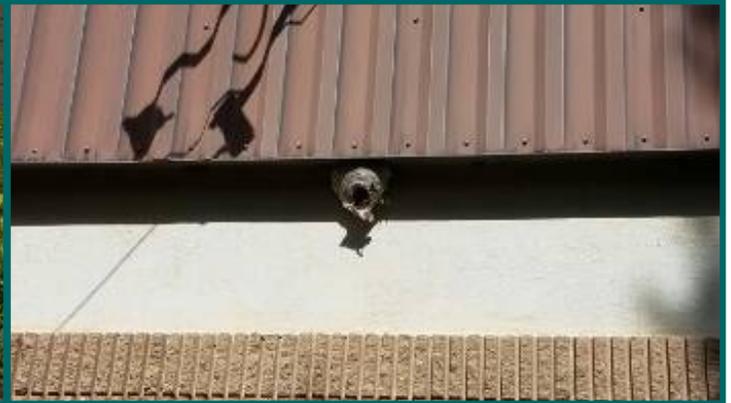
Wasp nest right side wall

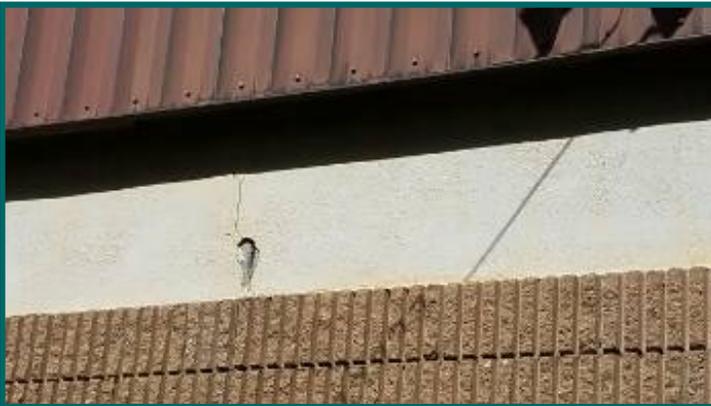
2.1. One or more areas of damage to exterior wall surfaces, recommend full assessment and repairs by a qualified contractor.

Damage to exterior surfaces at right side wall

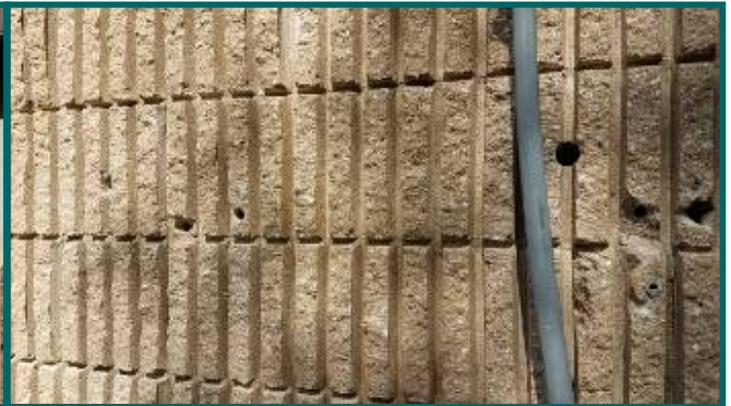
surface penetrations right side wall

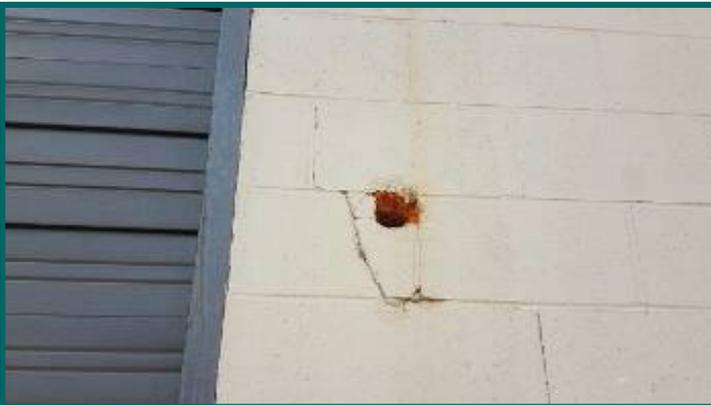
Damage to exterior surfaces at rear wall

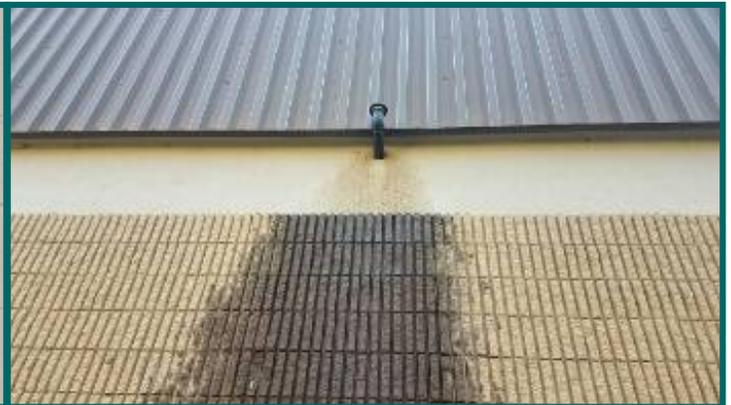
staining on left side wall reported to be from resin tank vent pipe

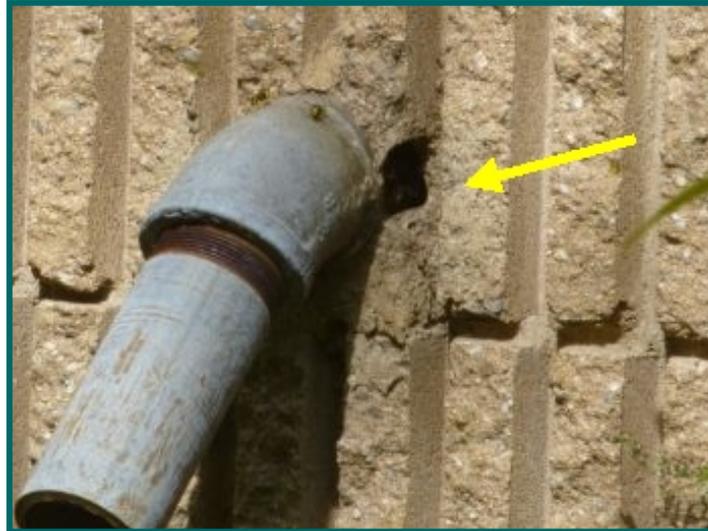
Bee hole right side of building

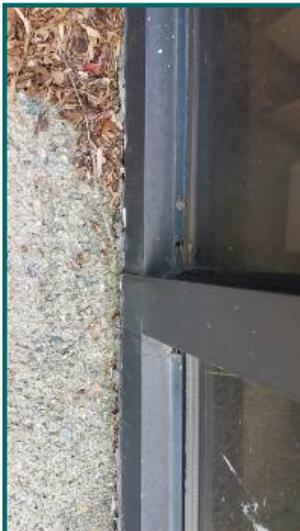
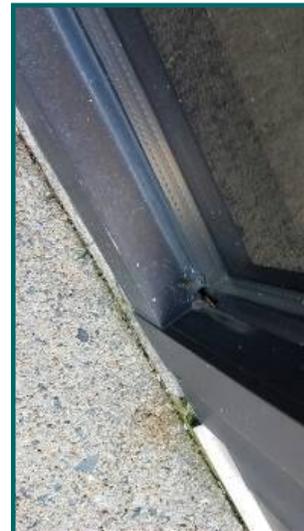
3.3. There are areas of damaged or missing caulking. Suggest caulking of doors and window frames as necessary.

front door sidelights need recaulking

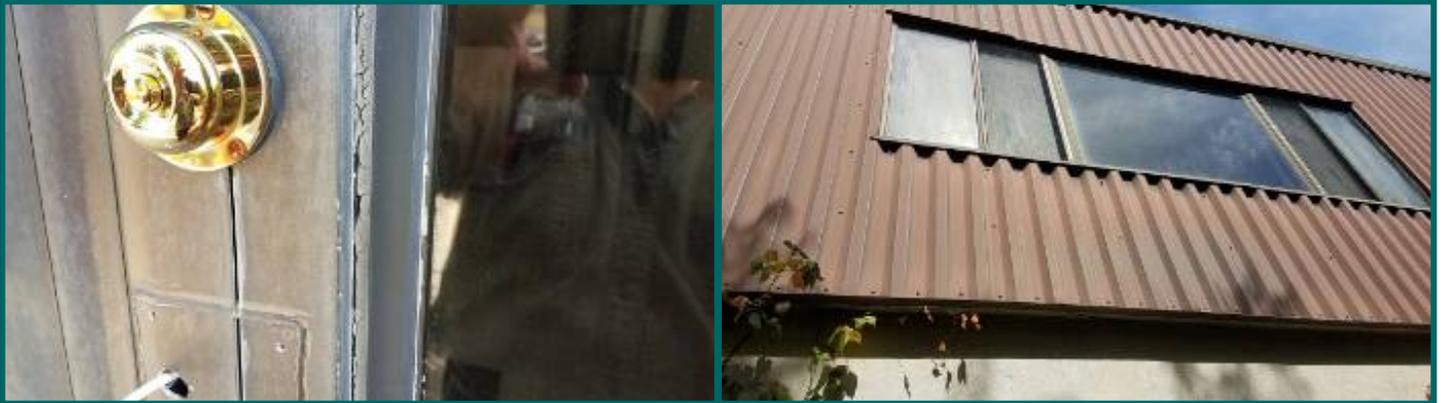
3.2. One or more windows have broken seals (fogged), this condition can diminish the energy efficiency of the window and cause permanent hazing to the glass, recommend repair by a qualified window contractor.

Fogged window at right side wall

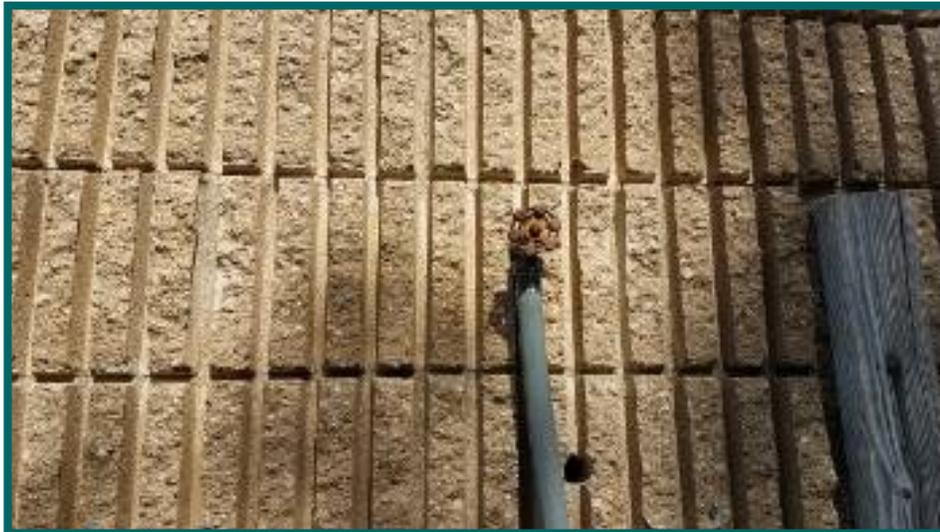
4.1. The water is shut off or not working to one or more exterior faucet, not tested. Recommend contacting building owner for confirmation of proper operation or assessment by a qualified plumber if needed.

Water is shut off or not working at exterior faucet at right side wall.

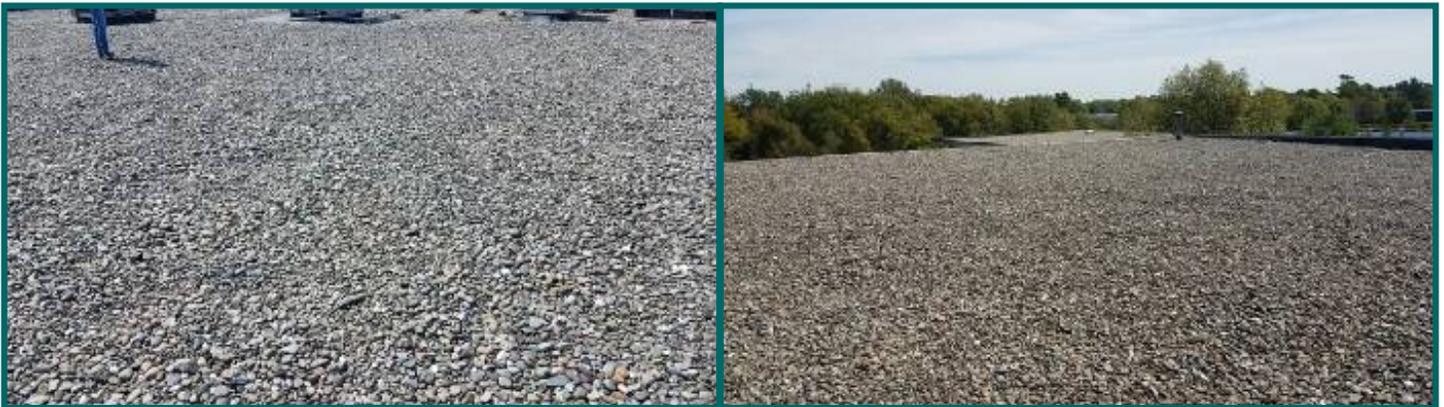
Roof is approaching or beyond its typical design life. There are many ceiling stains on inside space, active leaks were reported. Recommend full inspection and repairs or replacement as needed.

Roof is original reportedly being replaced areas of leaks reported

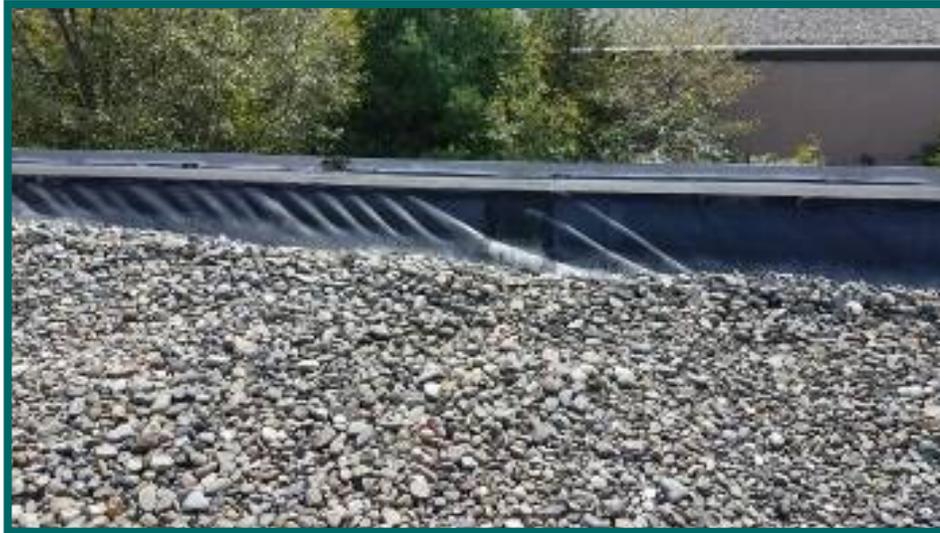
lifting roof services

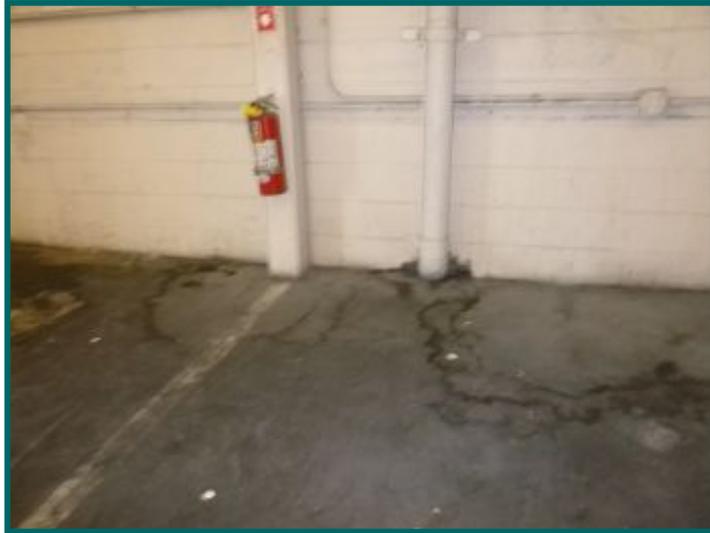
Gutter down spout inside warehouse space. Staining on floor slab.

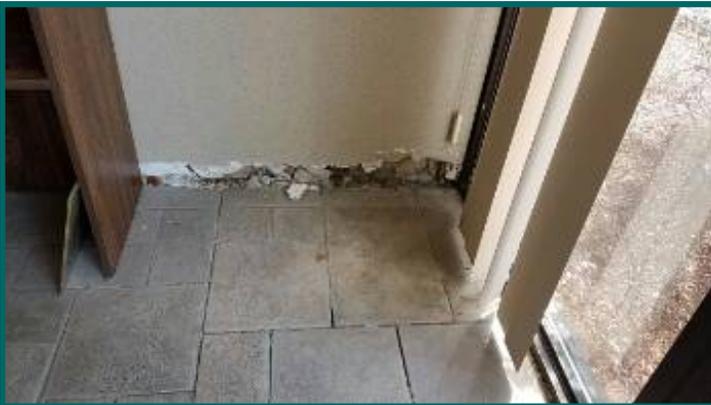
2.2. Water staining on floor, suspected water damage at front door area, recommend monitor for further water intrusion and repairs as needed.

Damage to wall at entrance area.

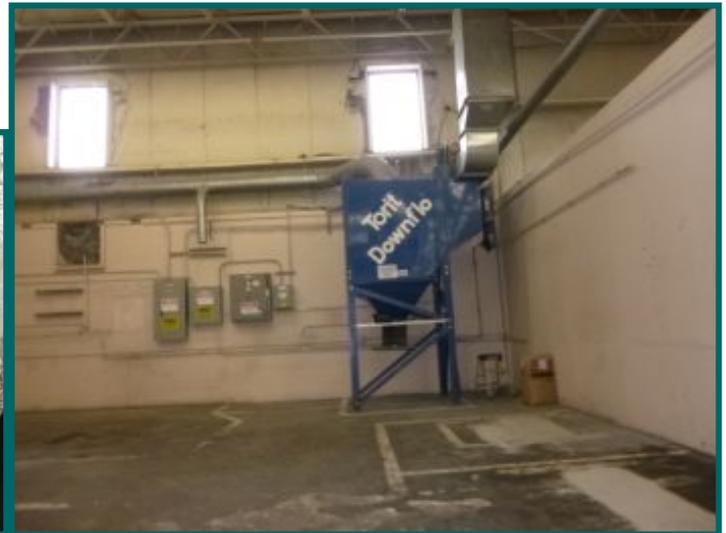
Water staining in warehouse area

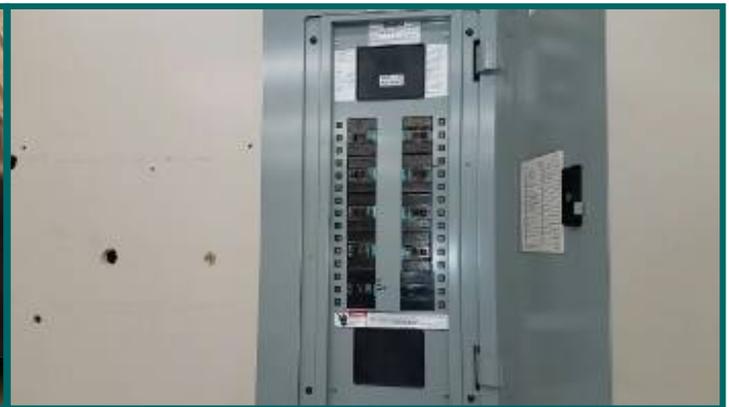
Breakers are all in off position at numerous panels in ware house, lab areas.

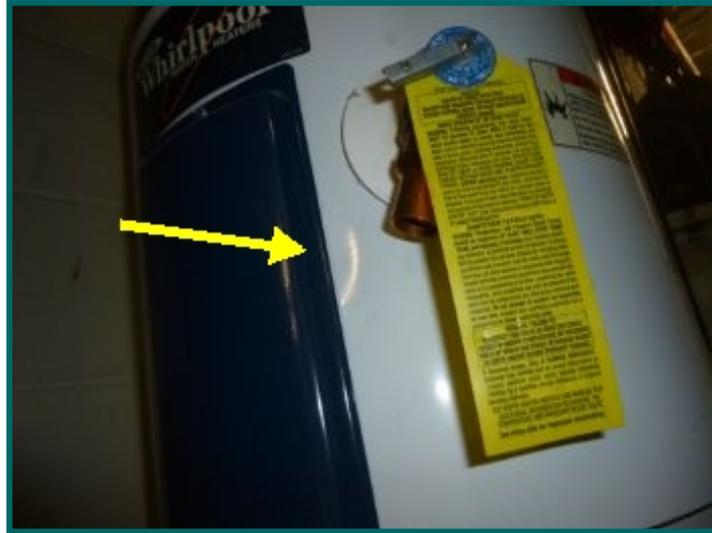
2.2. T/P relief valve extension is missing. Recommend installing of extension pipe that exits within 6" of floor. This is a safety item to prevent scalding in the event the temperature pressure relief valve releases hot water and or steam.

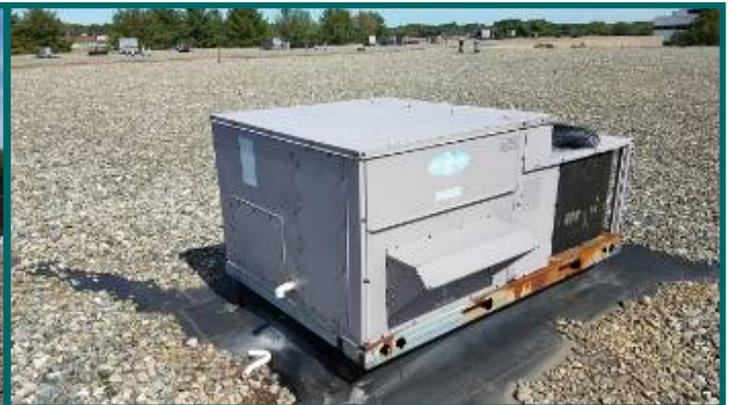
data plate not legible age unknown

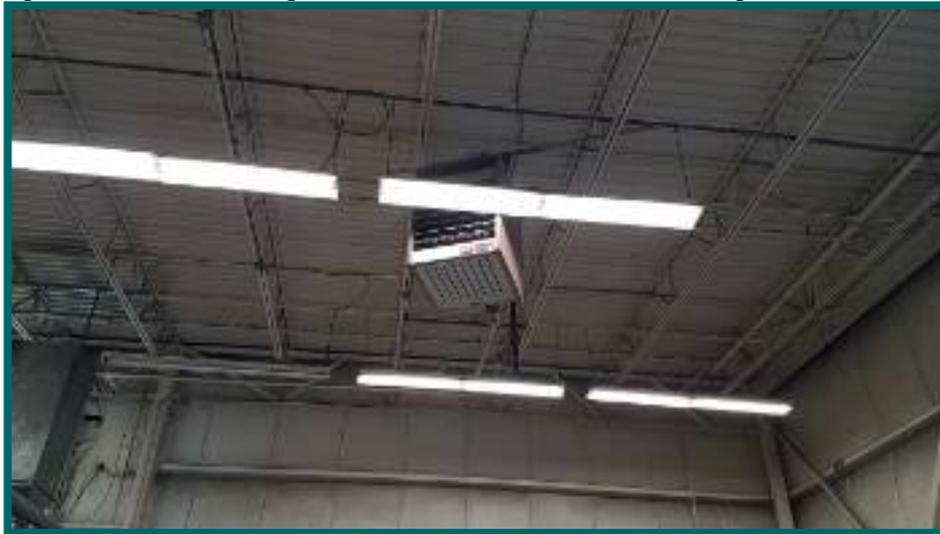
warehouse ceiling-mounted space heater not working

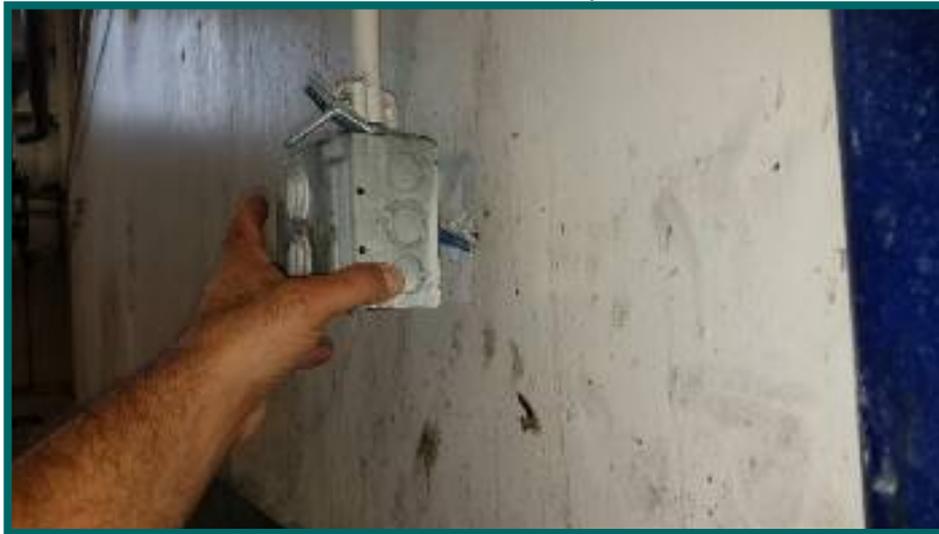
Loose outlet at ware house

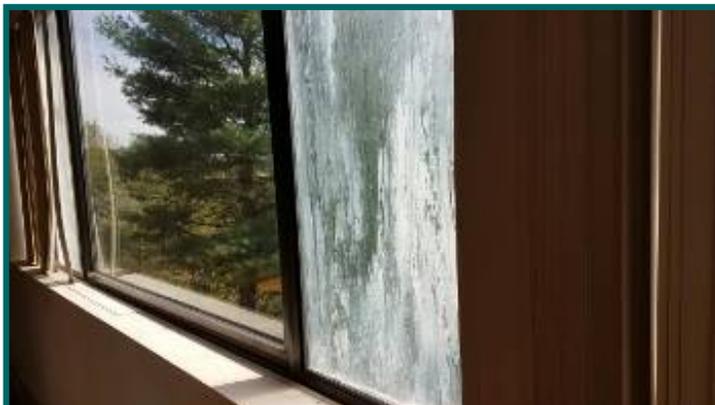
3.2. One or more windows have broken seals (fogged) this condition can diminish the energy efficiency of the window and cause permanent hazing to the glass, recommend repair by a qualified window contractor.

Fogged window at second floor office

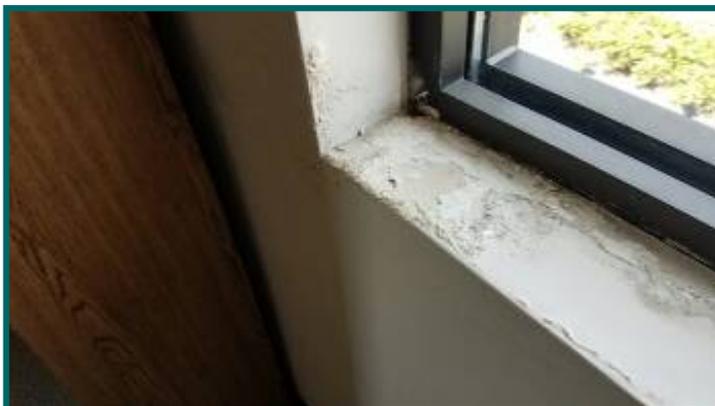
3.4. Window has moisture intrusion and / or wood damage to window or frame at one or more area of the building. Recommend assessment of windows and repair by a qualified tradesman.

damage to sill 2nd floor left side office

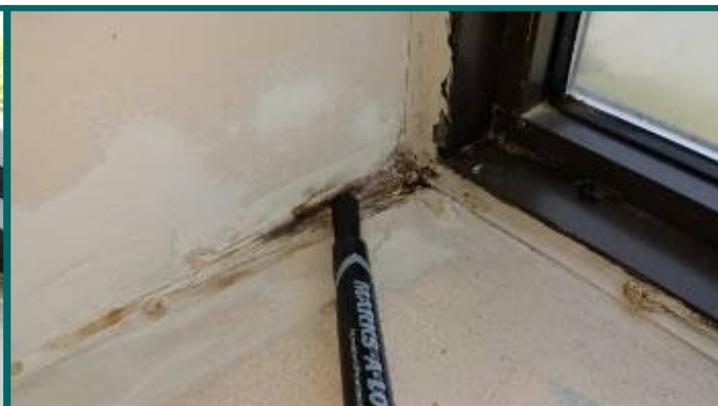
Damage sill water staining 2nd floor left side rear office

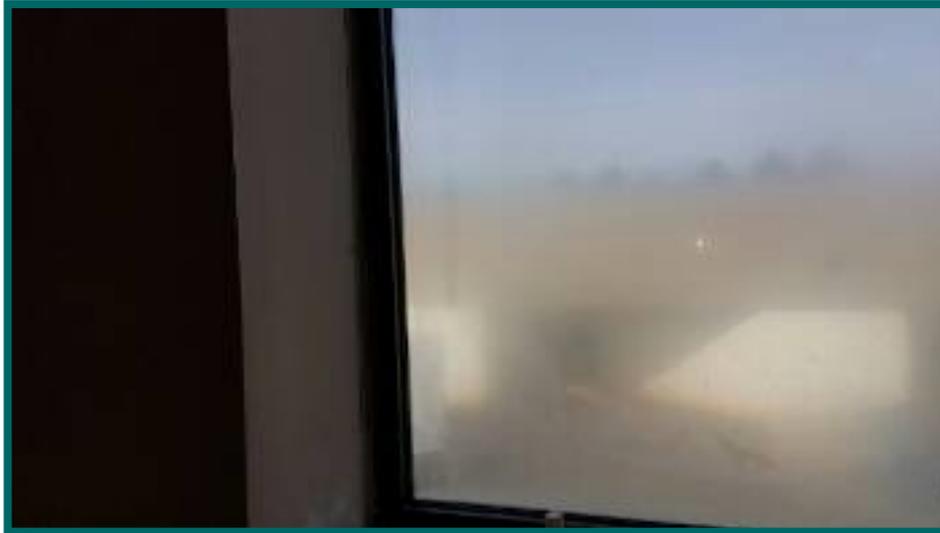
Fogged window at left side second floor

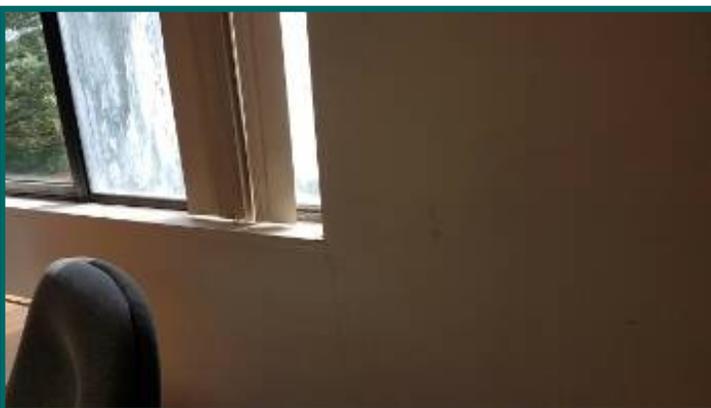
Stains on wall tested dry at right side front second floor office.

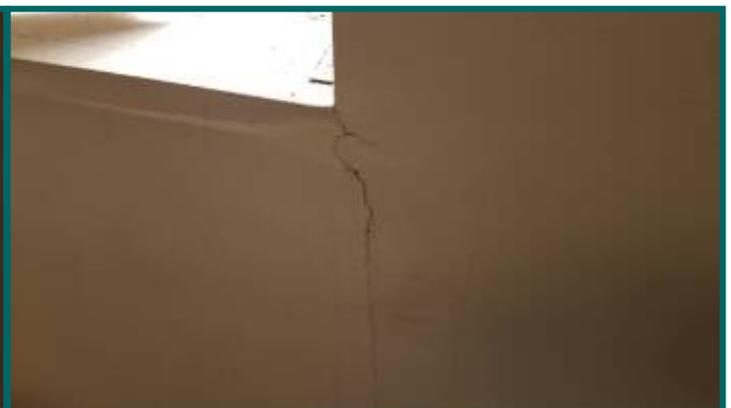
Damage to wall at second floor office

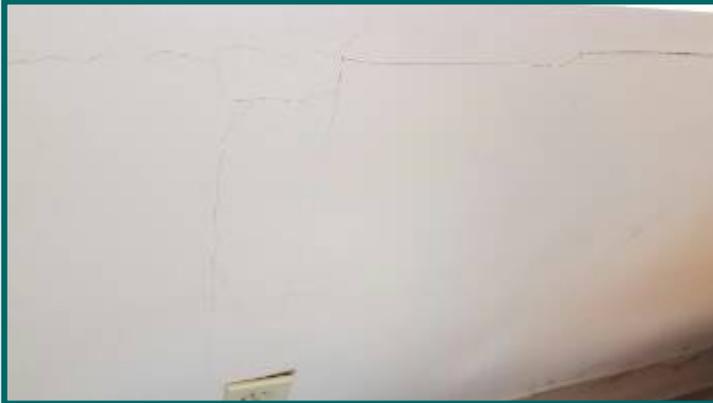
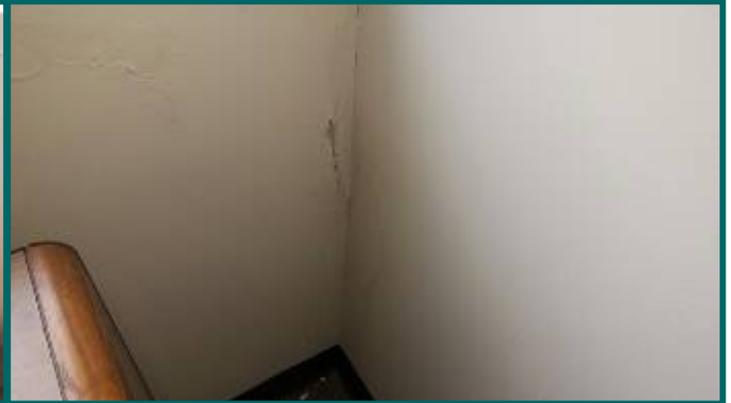
damaged wall below window 2nd floor left side office

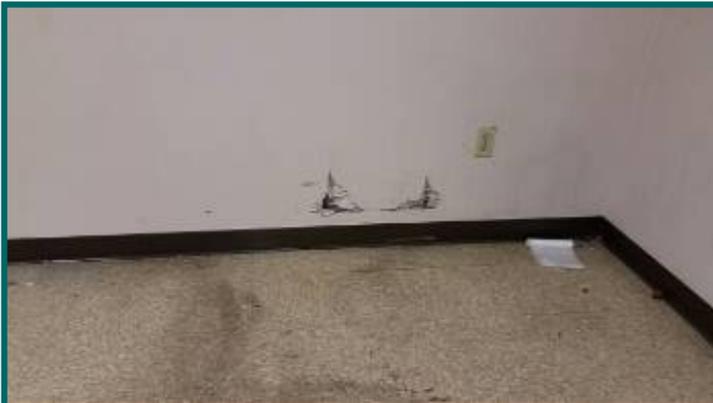
Damage to wall at 2nd floor left side

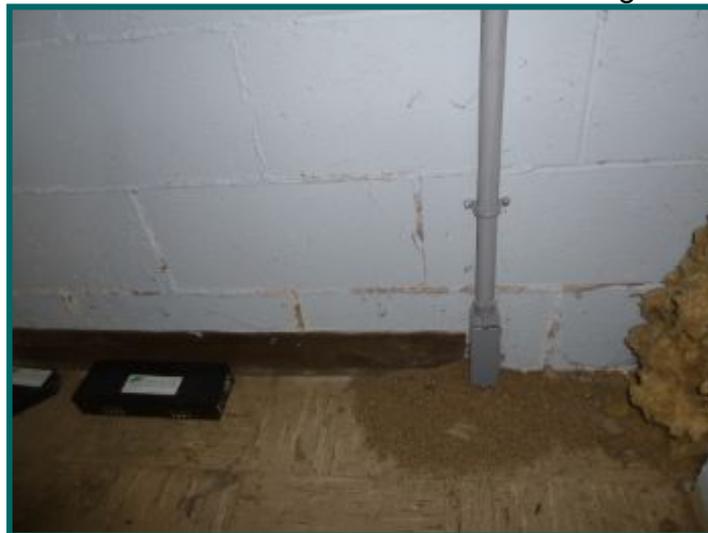
Water staining on block wall in electric room.

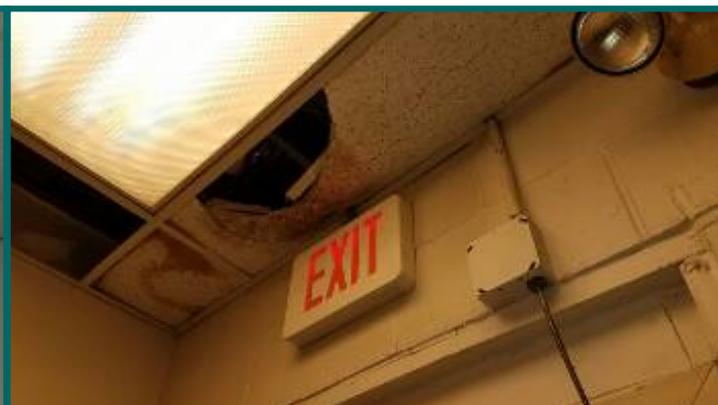
staining and damage left side exterior doorway

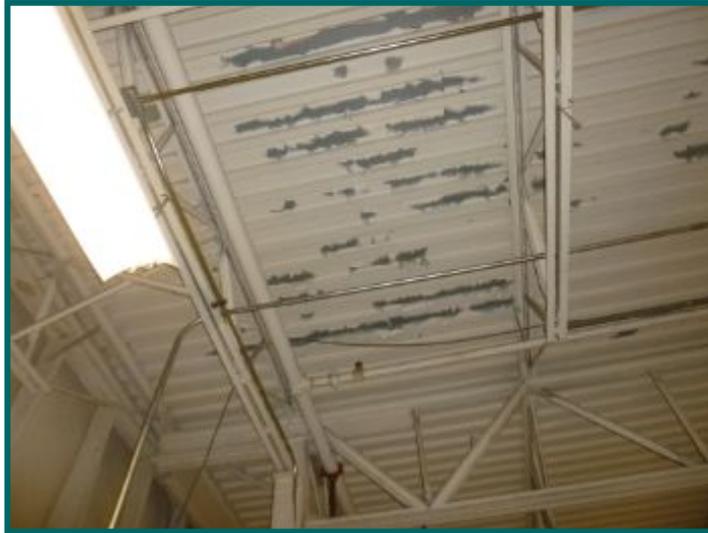
5.2. There is paint peeling on the ceiling at one or more area. Recommend scraping, prepping and painting as needed by a qualified tradesman.

Peeling paint in ware house ceiling.

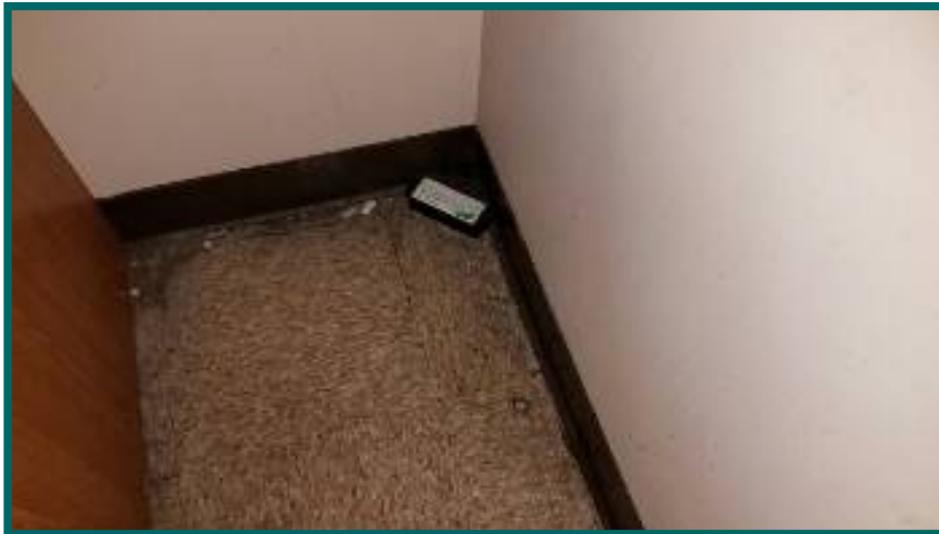
6.2. Rodent bait stations inside building, recommend maintenance of bait stations by a qualified pest control company.

Rodent bait stations 2nd floor office

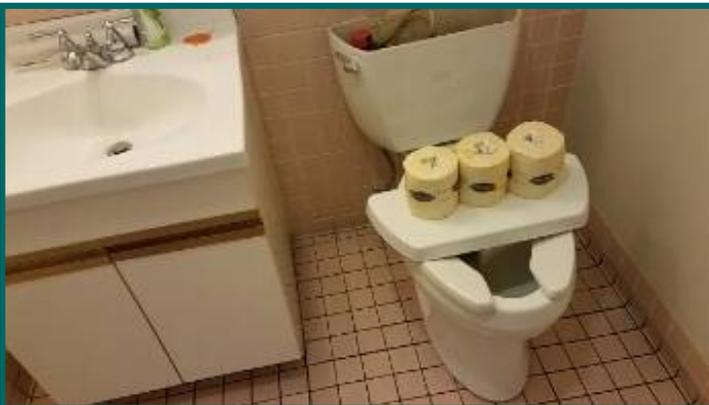
7.2. Water was shut off to one or more plumbing fixture Unable to test. Recommend, licensed plumber turn on water and assess all plumbing components.

water is shut off to numerous toilets

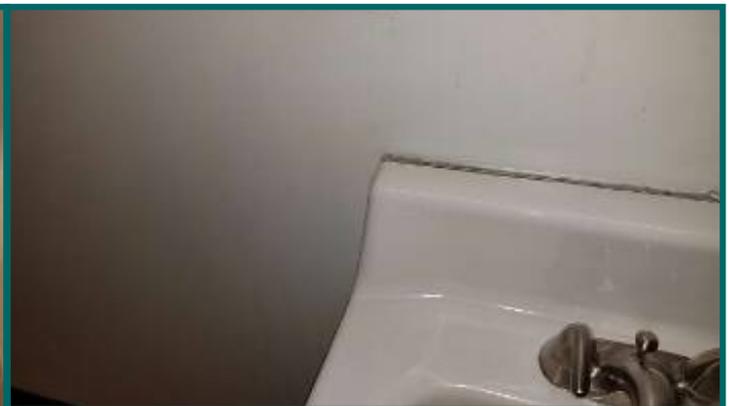
7.3. Sink is loose or damaged at one or more location, suggest repairs as needed by a qualified contractor.

sink is loose 2nd floor left side office area

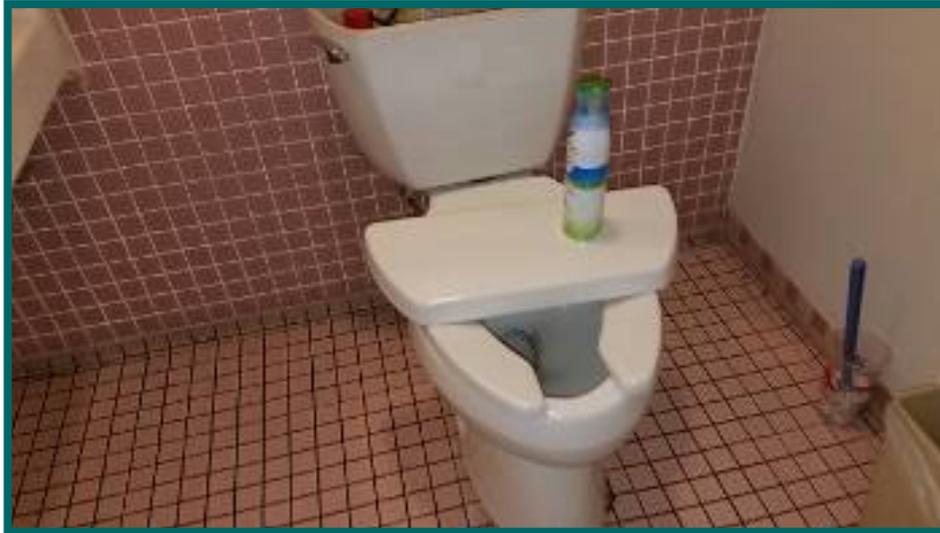
First floor toilet water shut off
