# *Alpha Home & Commercial Building Inspections*

## Property Inspection Report

Industrial Building Inspection Report Sample  
Inspection prepared for: Commercial Building Inspection Client  
Real Estate Agent: Brian Phillips - Conway Commercial

Date of Inspection: 9/21/2016 Time: 1:00 PM  
Order ID: 4365

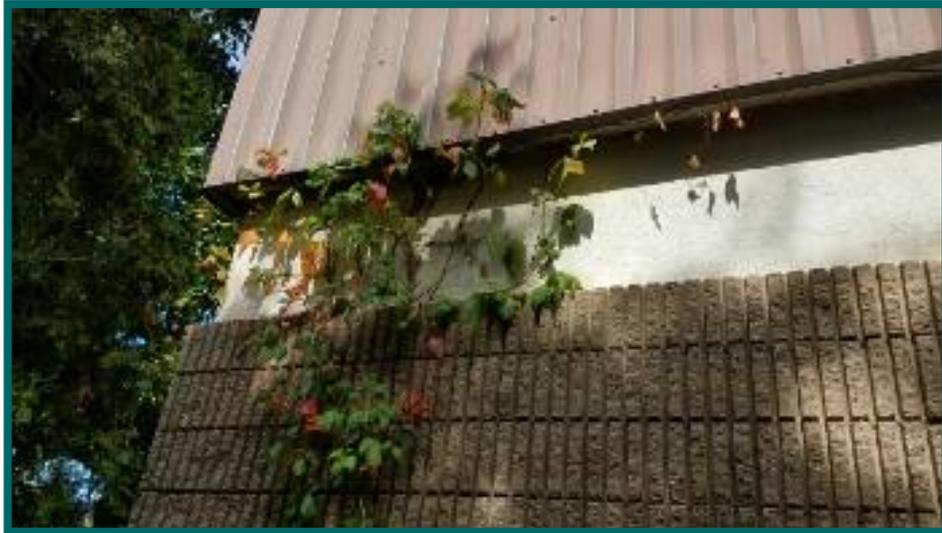
3.1. Vegetation such as trees, shrubs and/or vines are in contact with or less than one foot from the structures exterior. Vegetation can serve as a **conduit** for wood destroying insects and fungal growth and may retain moisture against the exterior after it rains. Vegetation should be pruned and/or removed as necessary to maintain a one foot clearance between it and the structures exterior.

right side wall

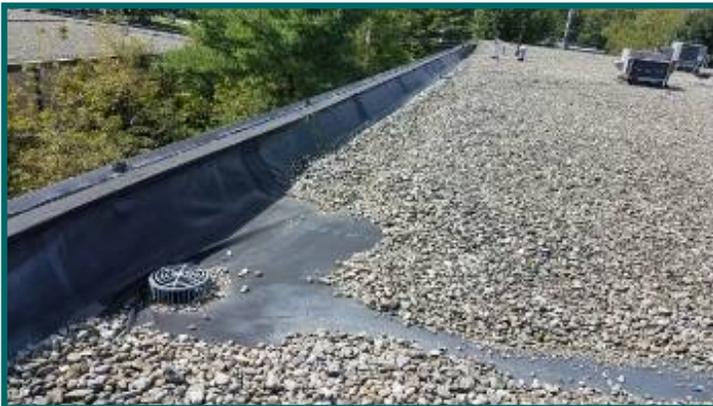
internal roof drains

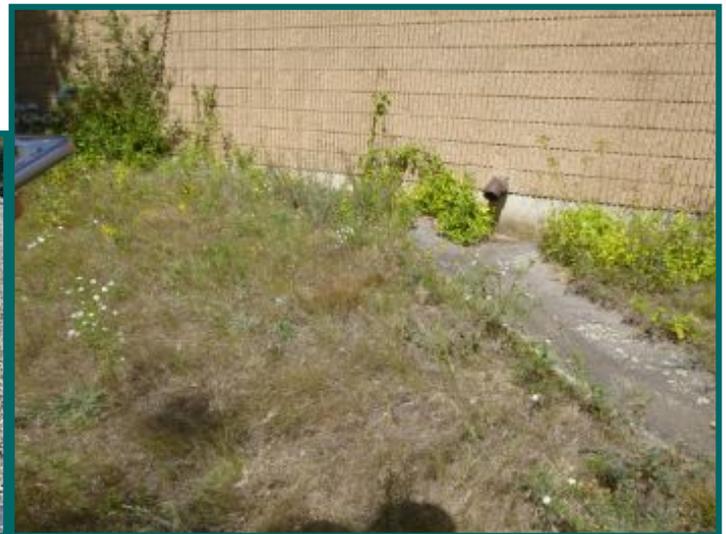
2.1. The roof is drained through an internal gutter system along the right side of the building. Down spouts terminate to asphalt sways at right exterior directing roof run off away from the building. These sways should be kept clear of debris and maintained. There is water staining inside building at floor slab area. This area should be monitored for water intrusion and maintenance or repairs if needed during heavy rains and snow melting.

Roof gutter drain terminations at right side exterior wall

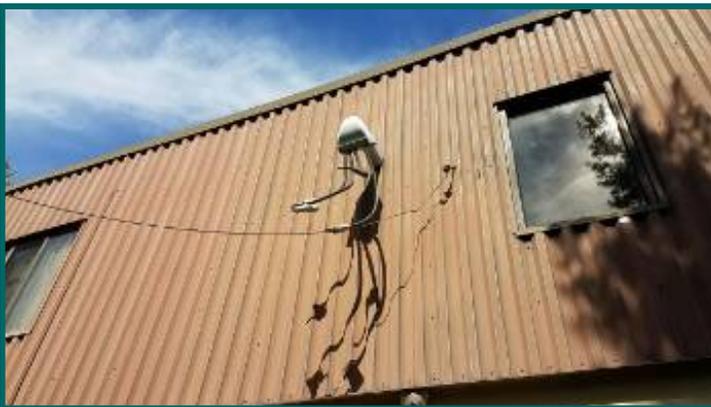
terminated overhead service not in use

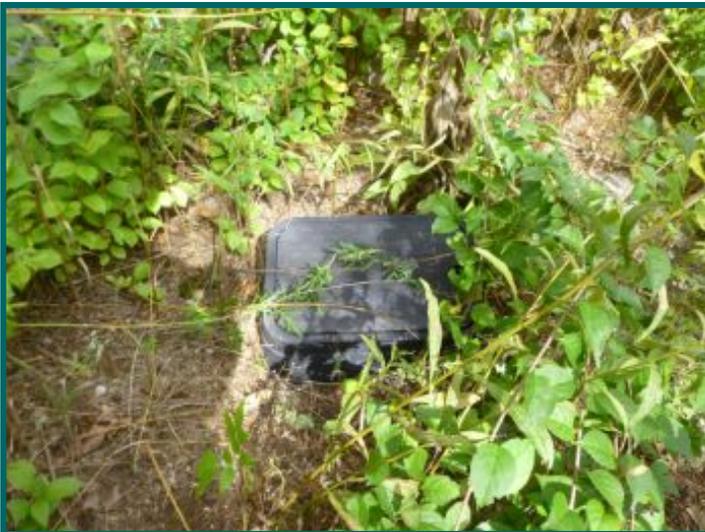
1.6. The lawn irrigation system was not operated or inspected, system may not be in operation. System will need to be assessed and shut down by a qualified contractor prior to winter and start up in spring by a qualified lawn irrigation company. Recommend asking building owner for service history to confirm system is in operational condition.

Valve box for landscape irrigation at right side of building

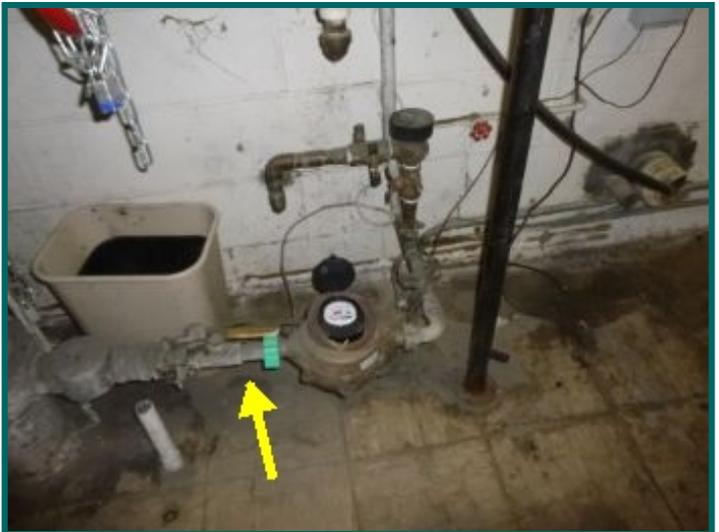
Main water shut off valve is located at water meter.

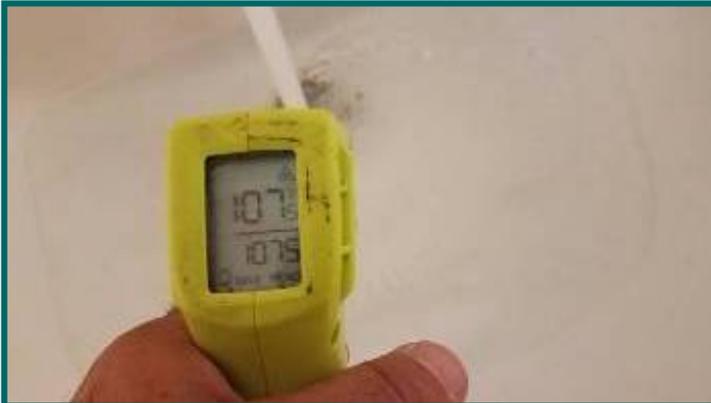
Water Temperature

- Building is serviced by a single 30 Gallon electric water heater 12 years old, typical design life for water heater is 10-15 years. Water heater appears to be in acceptable condition and working except where noted.

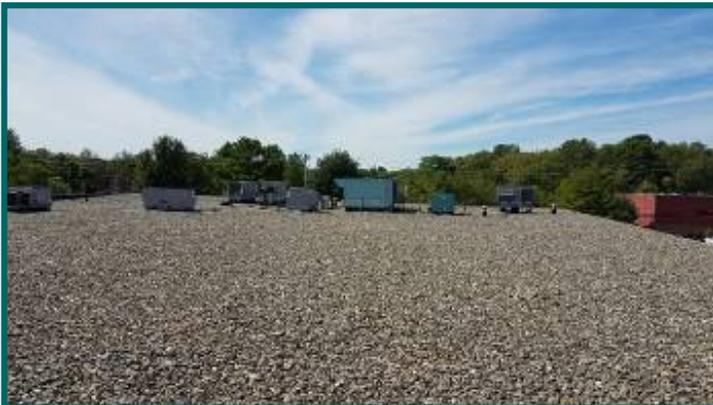
1.1. The building heating and cooling is provided by seven roof top heating and cooling package units, one package unit cooling only, one split mini ductless AC system for data room, two electric baseboard heaters and two ceiling mounted gas fired heaters. The mechanical systems manufacturers date ranges that were legible are from 1993 to 2016. When tested at interior air registers, all zones had AC working, three zones were not providing heat. There are two ceiling mounted Reznor gas fired space heaters in warehouse area that would not start up. There are two electric wall baseboard heater worked when tested. Some components are well beyond their typical design life and will need replacement in the near future. Some areas of heat are not working. It was reported that a preventative maintenance was performed on the system Spring 2015 by Costa Mechanical 508-726-8744. I spoke to Sal Costa he reported that he performs service only not installs. During his last service in 2015, he replaced two heat exchangers on RTU's and changed filters and checked belts. He did not work on large roof top AC unit, he made recommendations for repairs on that unit that were not done. Service history and records were not provided. Client should consult mechanical engineer or designer to determine HVAC needs for fit up and loads for future use of building, and full assessment repairs, modifications and replacement of components as needed by a qualified HVAC contractor.

7 rooftop package units, 1 roof top mounted compressor for ductless split and 1 rooftop compressor for split system

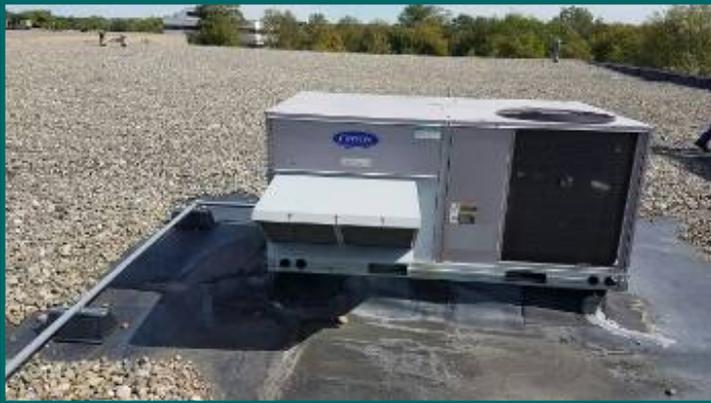
15 years old

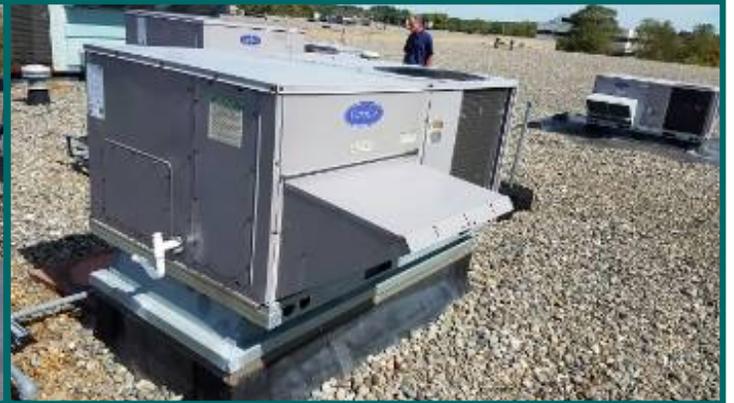
9 years old

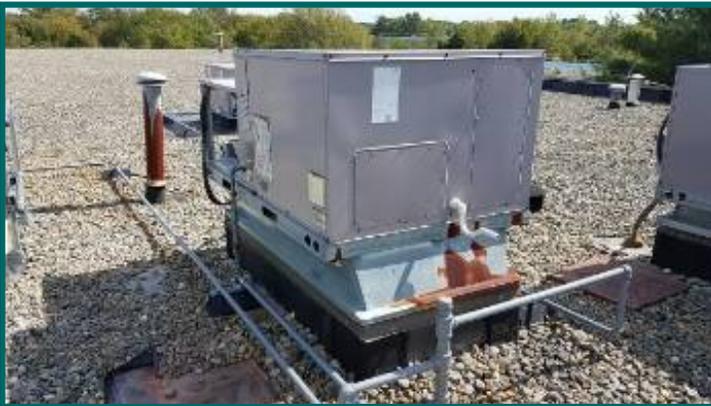
7 years old

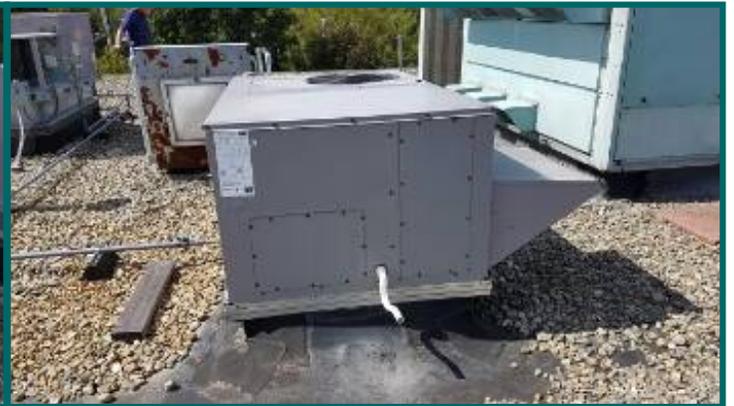
7 years old

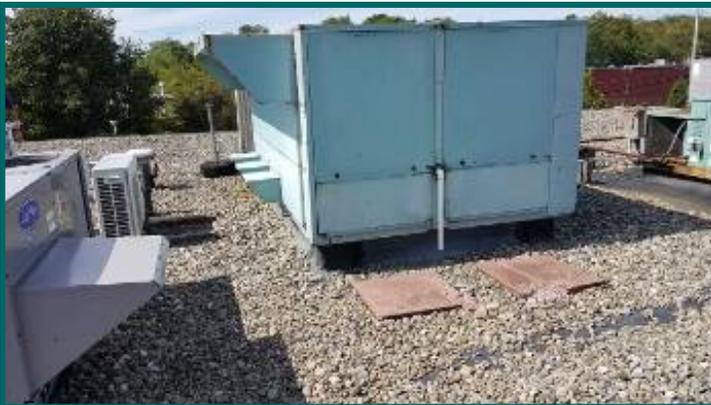
rooftop AC unit for warehouse space 30 plus years

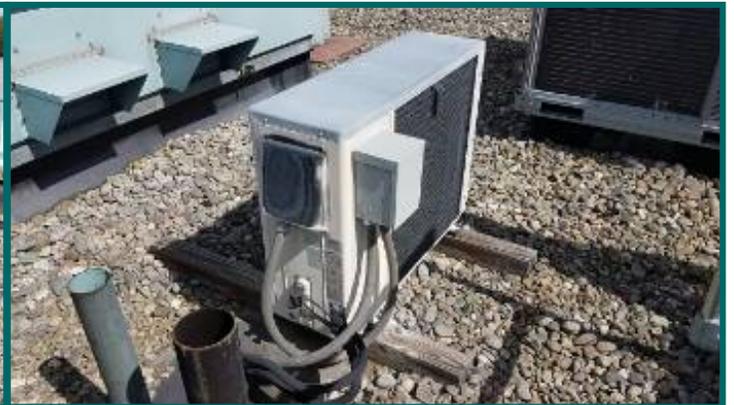
mini-split AC compressor for data room, eight years old

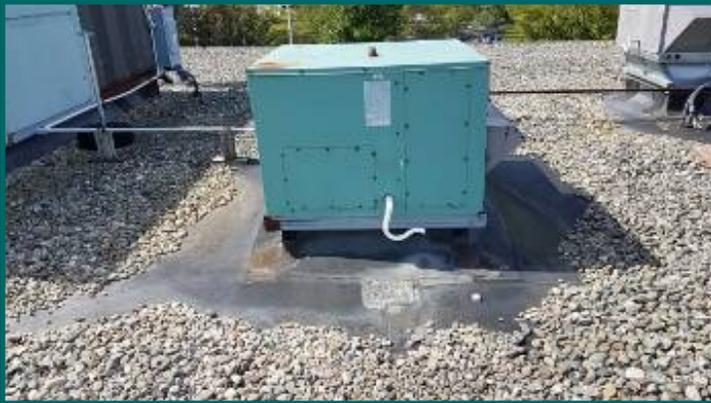
23 years old

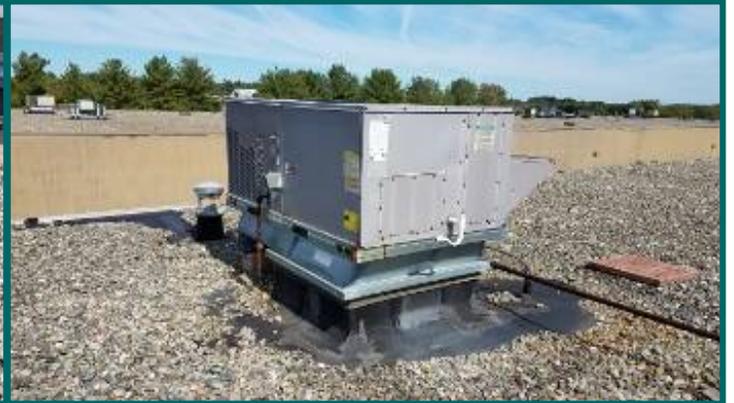
9 years old

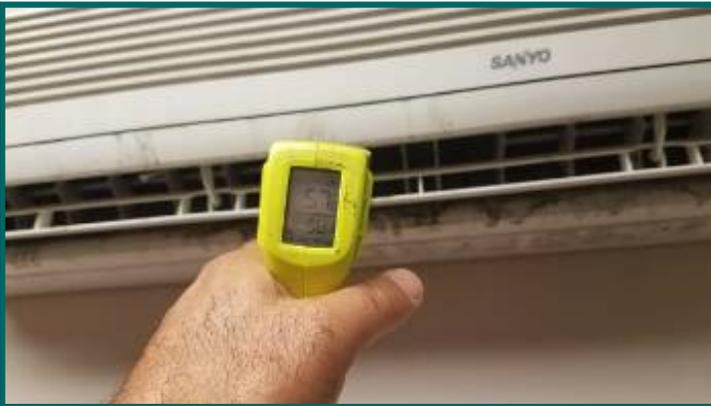
data room split cooling ok

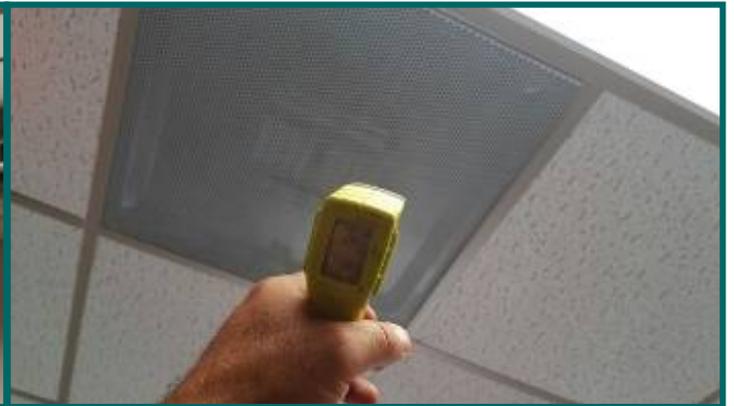
heat working at 2nd floor

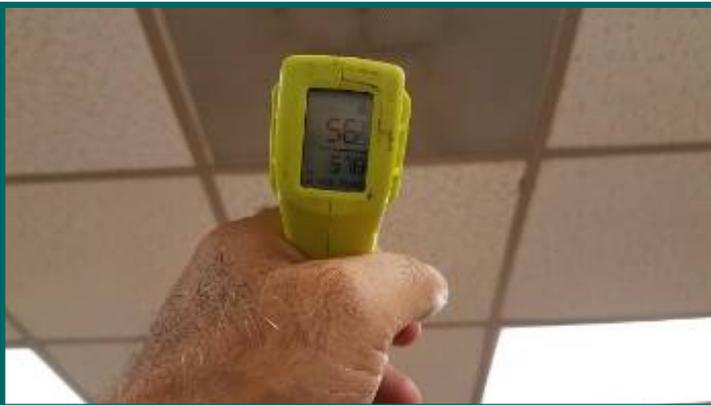
2nd floor middle zone AC working

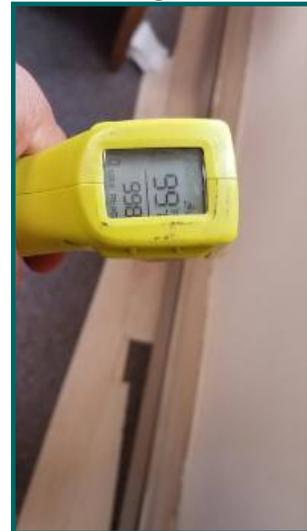
2nd Floor Electric wall heaters working

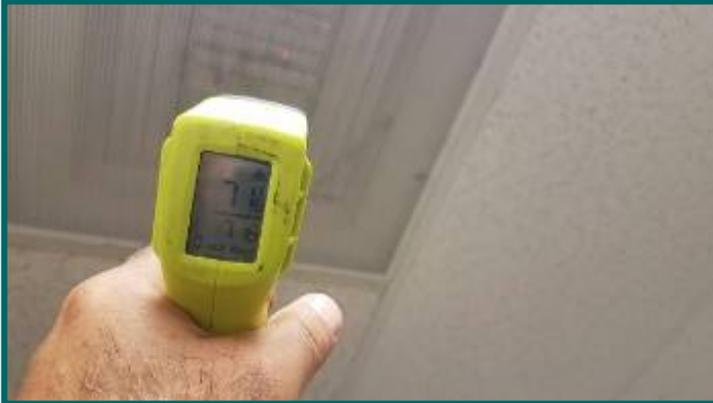
2nd floor left side Zone heat not working

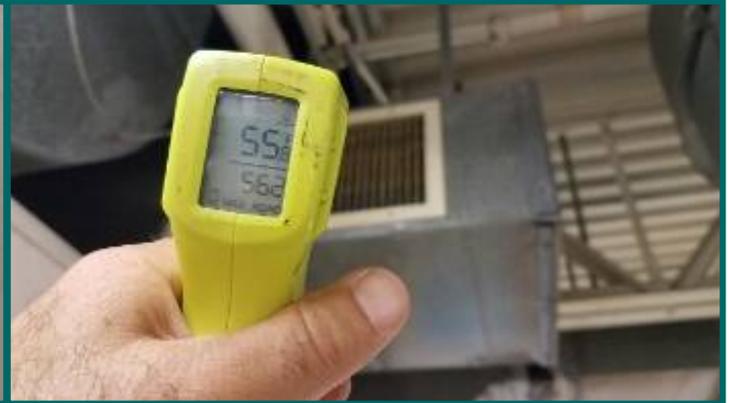
open area zone AC working

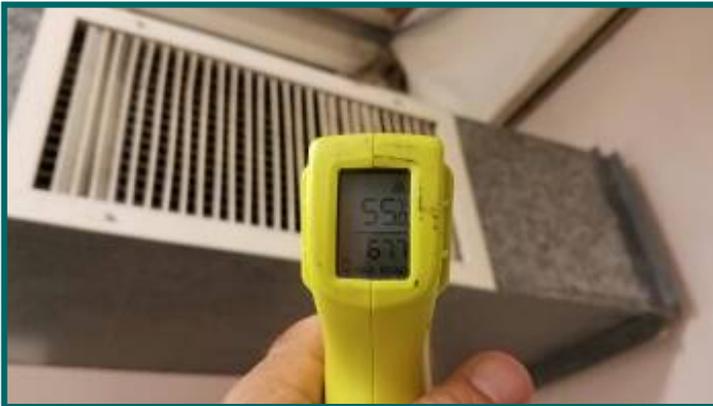
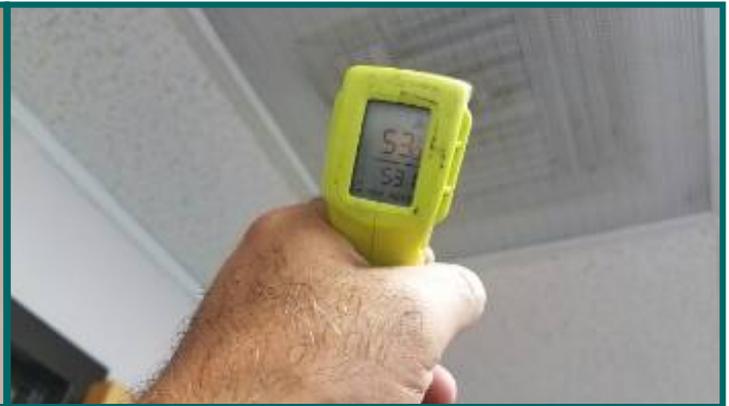
2nd floor right side Zone AC working

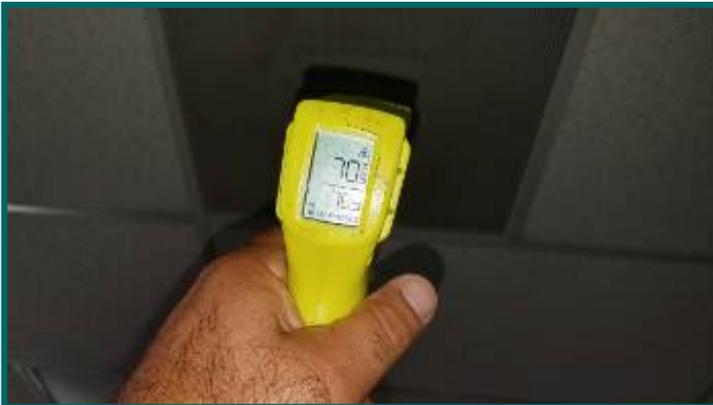
heat not working 2nd floor left side office Zone

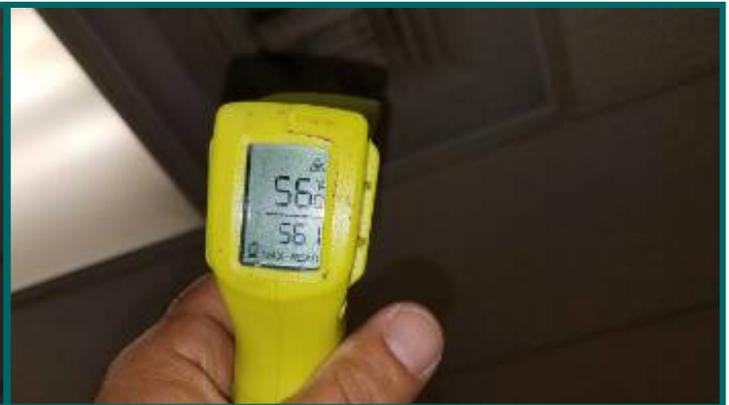
AC tested and blowing cold second floor left side office zone

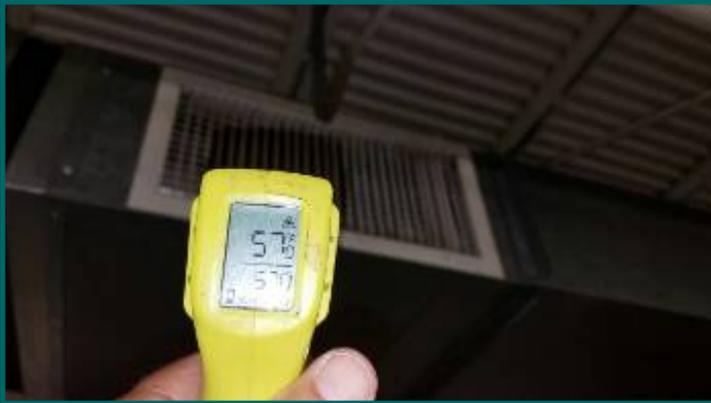
first floor right side AC blowing cold

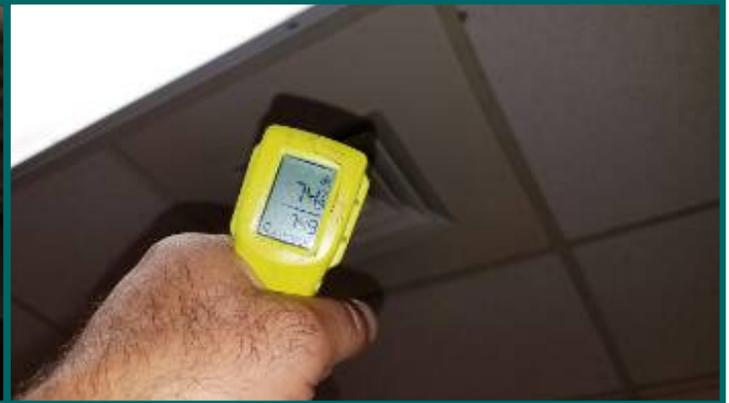
heat not working first floor left side office area

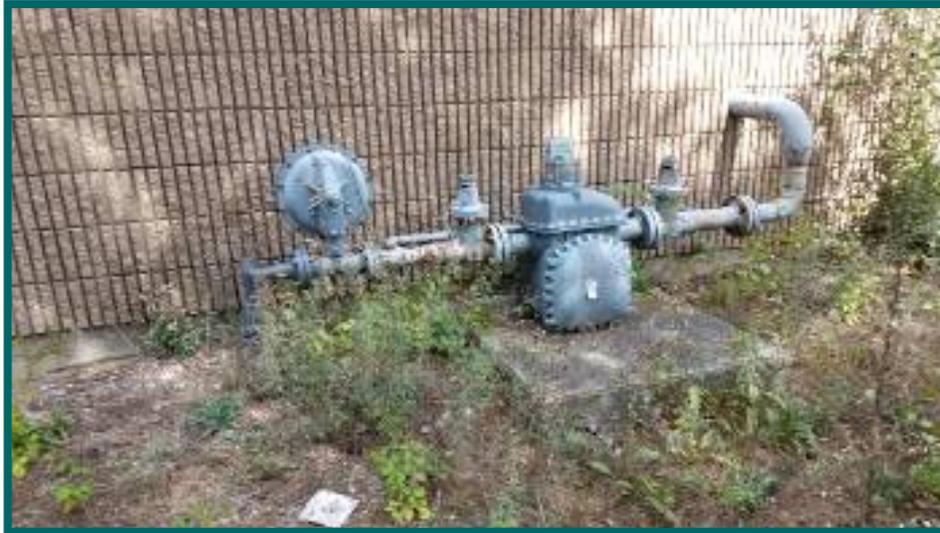
Gas Meter

2.4. Welded and threaded black iron pipe is used for gas supply distribution throughout the subject property.

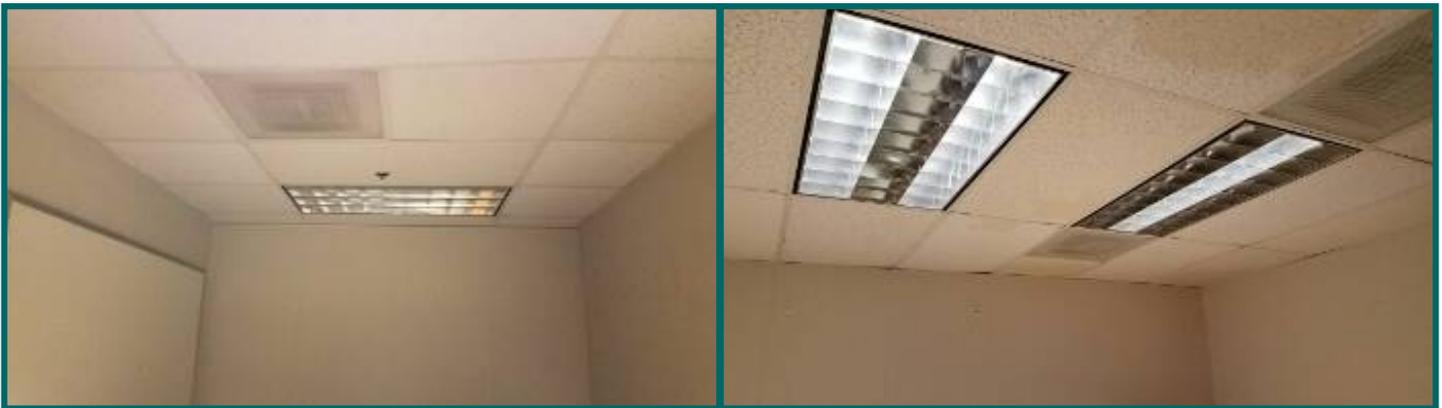
, right side office light out

one more office area bulb is out

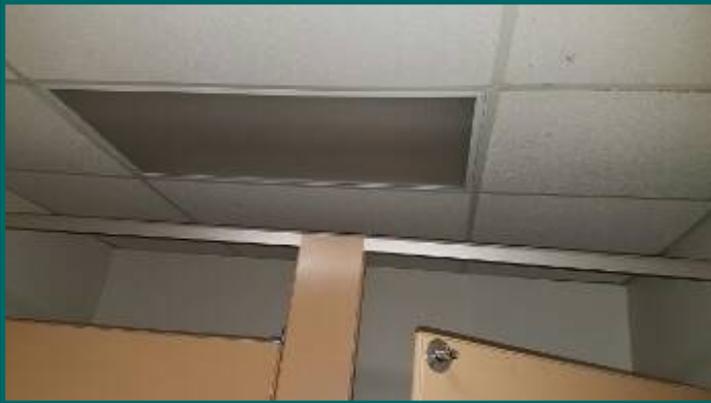
Light is out at first floor bath

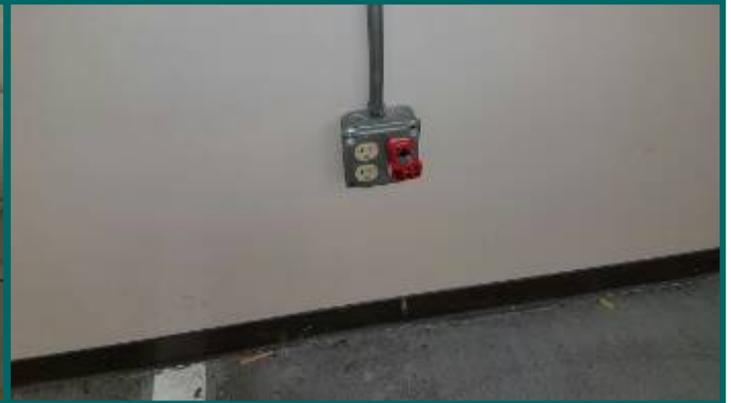
No power to outlet at first floor left side lab

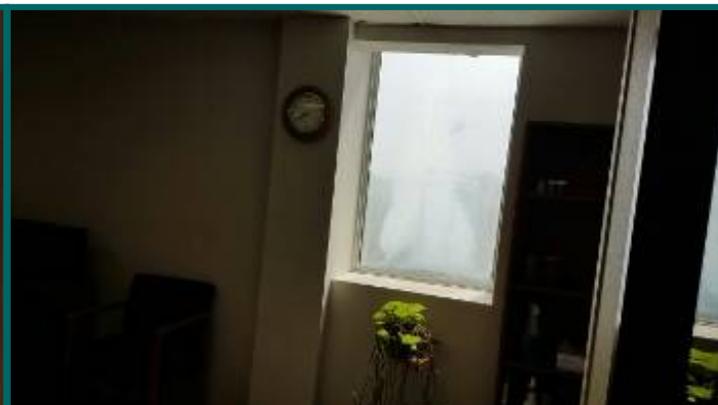
3.2. One or more windows have broken seals (fogged) this condition can diminish the energy efficiency of the window and cause permanent hazing to the glass, recommend repair by a qualified window contractor.

2nd floor right side rear office window fogged

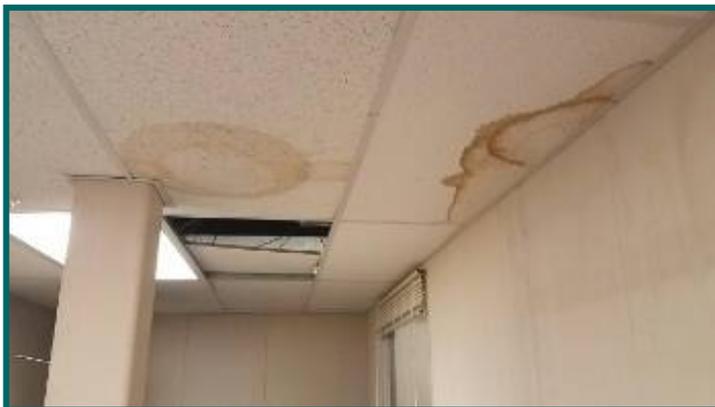
Data room

5.3. Stains noted on ceilings in one or more area of building. This is evidence of past or present leaks. They tested dry at the time of the inspection. Recommend asking current building owner for the source and history of any leaks or water intrusion, assessment and repairs by a qualified contractor of any affected areas and monitor for further water staining.

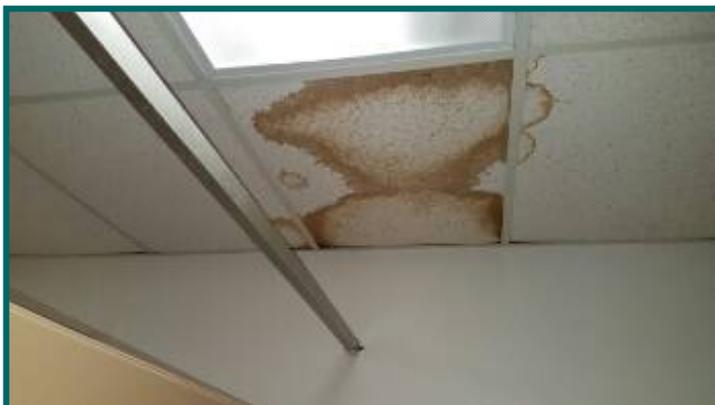
first floor bathroom ceiling

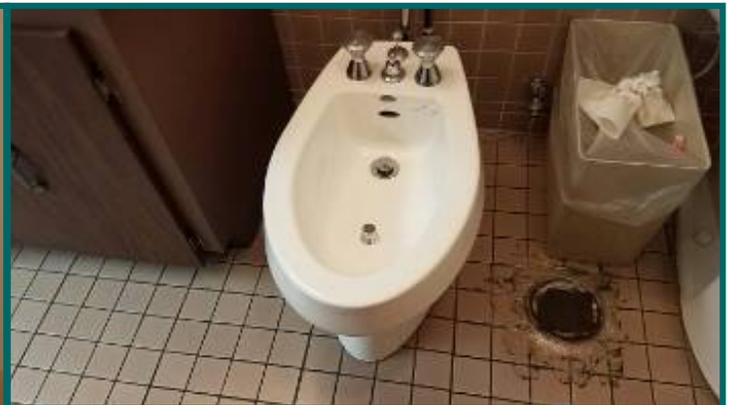
Bidet not operated

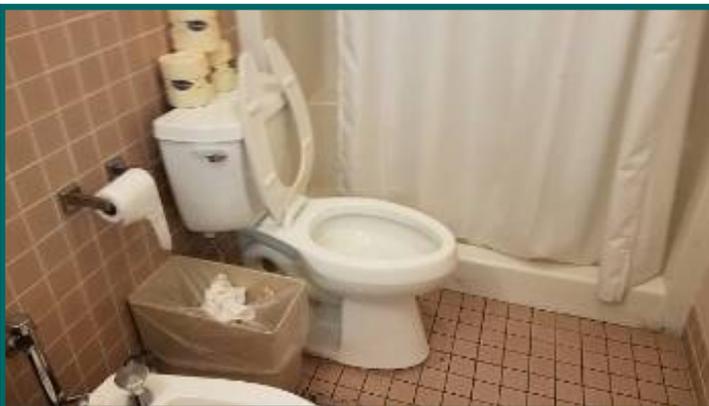
7.2. Water was shut off to one or more plumbing fixture Unable to test. Recommend, licensed plumber turn on water and assess all plumbing components.

2nd floor office water shut off to toilet
